HANDLE SPRING REPLACEMENT INSTRUCTIONS

Handle Return Spring part number: TB24796B01

**BT2HT, BT2HTI & RT2HT
HANDLE SPRING REPLACEMENT INSTRUCTIONS**

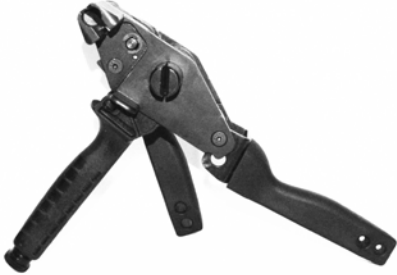
<p>1. Move the Back Handle away as shown.</p>

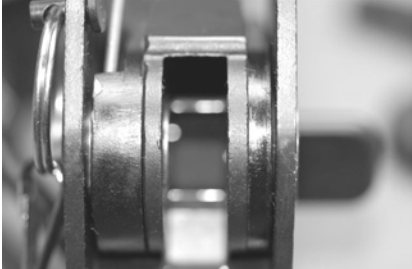
<p>5. Remove the Ratchet and put it aside.</p>

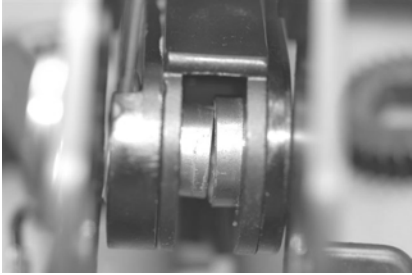
6. Push both Bearings inside.

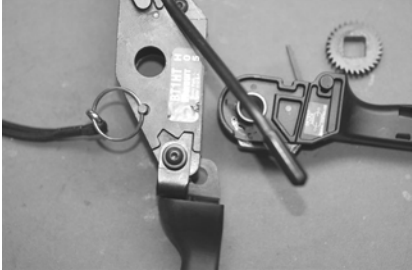
7. Remove the Front Handle.

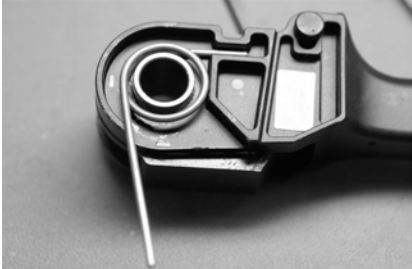
8. Apply Grease (Versalube G326 or equivalent) on the Handle Spring and place it around the smaller Bearing.

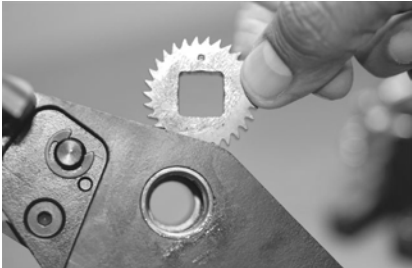
9. Slide the Handle back into the Tool Body with Handle Spring.	
10. Push the Bearings out to flush with Tool Bodies.	
11. Make sure the dot on the Ratchet is towards you. Slide the Ratchet in.
